CHAPTER H-5 LEVEE CLOSURE SYSTEMS

H-5.1 Key Concepts

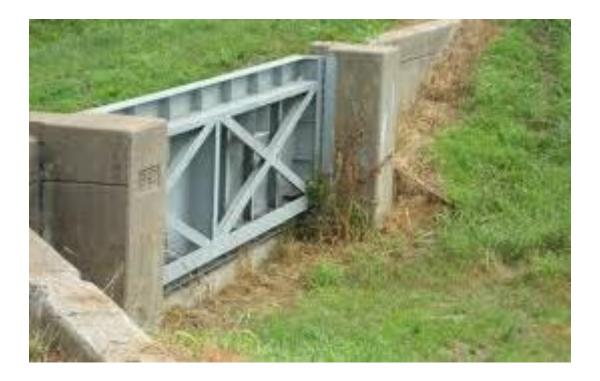
Figure H-5-1. Example of Levee/Floodwall Closure Structure

Levee closure systems are usually temporary structures that are put in place at openings along the embankment/floodwall to provide flood protection when the river/stream is elevated. The openings are typically for vehicular, rail, or pedestrian access through the embankment/floodwall when the river/stream is at normal levels (non-flood). A simple example of a levee/floodwall closure is shown in Figure H-5-1 which shows a small gate structure used for pedestrian access.

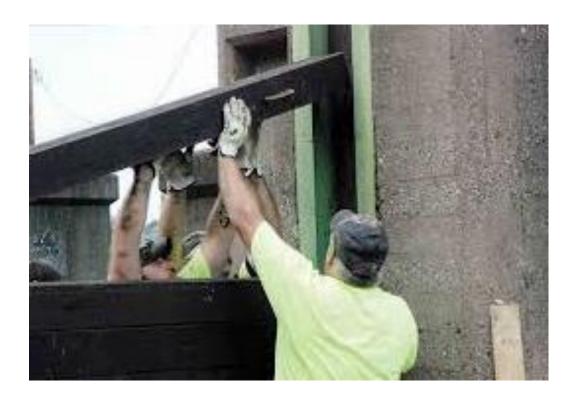
Figure H-5-2. Setting Stoplog Closure

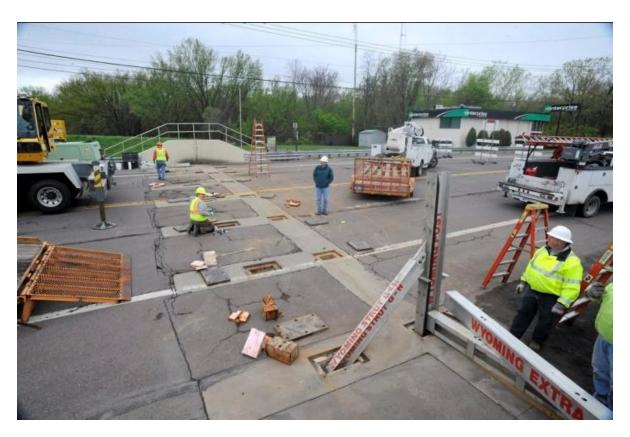
Figure H-5-3. Installation of Post/Panel Closure Utilizing Vertical Support Posts

Post and panel style closures are similar to bulkhead/stoplog closures except the panels (vertical or horizontal alignment) require the use of structural support other than the adjacent wall section in order to span a wider opening. The support structure usually comes in the form of a vertical post with accompanying foundation slot or a structural frame. Examples of both of these are shown in Figure H-5-3 (vertical post) and Figure H-5-4 (structural frame), respectively.

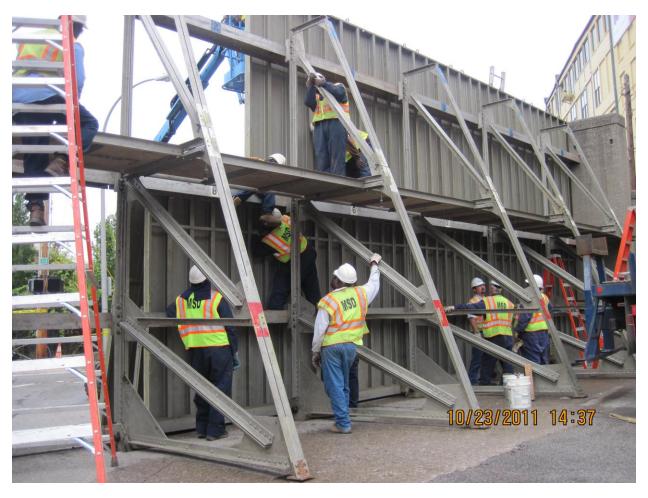
Figure H-5-4. Setting a Post/Panel Closure with Supporting Frame

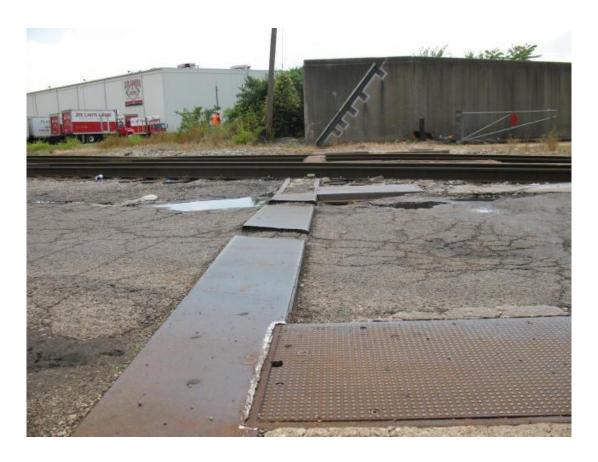
Figure H-5-5. Deteriorated Bearing Sill for Combination RR and Road Closure

Another significant concern with respect to both stoplog and post/panel closures is the condition of the bearing sill. There are many instances where the sills have been severely damaged from a combination of traffic, weathering, and road changes/maintenance. Figure H-5-5 shows a deteriorated sill structure for a combination railroad and road post/plane closure. There have been numerous cases where it has been so long since the closure was set that the bearing sill has been paved over and is no longer visible. The condition of the bearing sill should be included as part of the overall assessment of the closure superstructure when assessing the risk of these features.

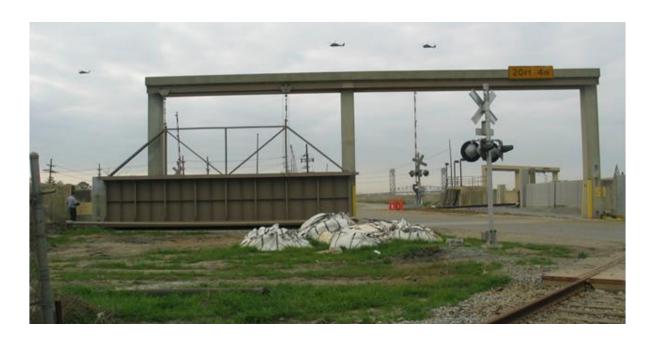
Figure H-5-6. Overhead Trolley Rolling Gate Closure for Floodwall

Moveable gate closures are usually the simplest type of non-culvert closure to set. They are gate structures that are moved into place by either manual or mechanical means. The gates are permanently attached to the closure superstructure (adjacent closure wall section) in the recessed or open position and then simply moved into place ahead of the rising floodwaters. Once moved into their final position (recessed or closed), they are secured by some type of locking mechanism so they don't move. There are a variety of styles of moveable gate closures (overhead trolley rolling, roller, and swing gates are typical). An example of each type is shown in Figures H-5-6 through H-5-8.

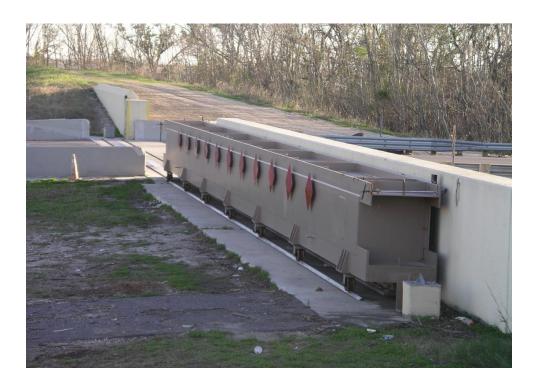
Figure H-5-7. Roller Gate at Levee Road Crossing

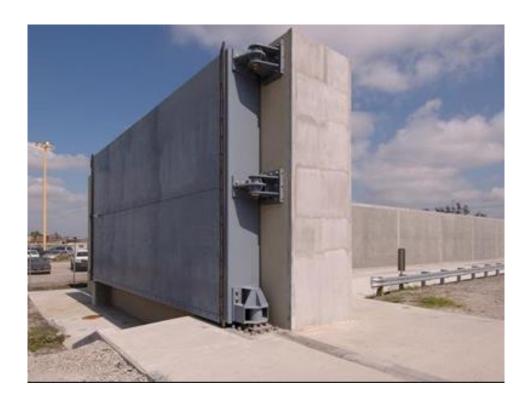
Figure H-5-8. Swing Gate Closure

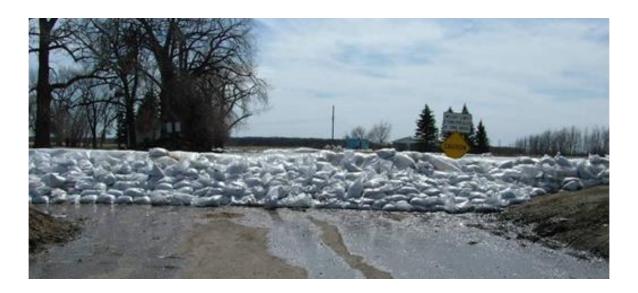
Figure H-5-9. Sandbag Closure at Road Crossing

Sandbag closures are likely the most common type of access closure in existence due to their low cost of implementation and simplicity; however, their use has limited applications. Sandbag closures should only be used when the height of the closure (elevation from base of sandbags to the top) is no more than 4 feet and there is ample time to set the closure. There has to be enough time and enough workers/volunteers to fill the bags, move them to the site, and then set them in place. A typical sandbag closure is shown in Figure H-5-9.

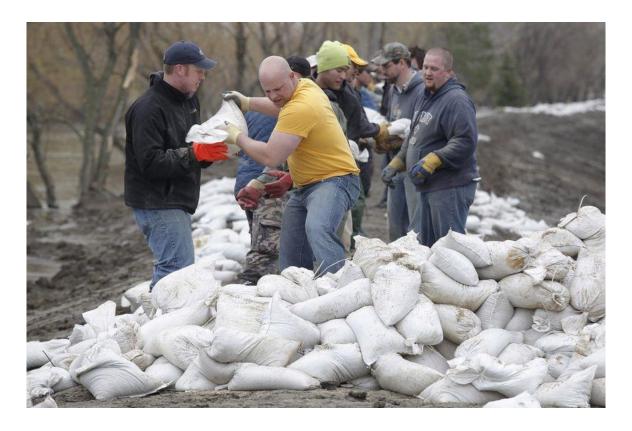
Figure H-5-10. Incorrect Placement of Sandbags

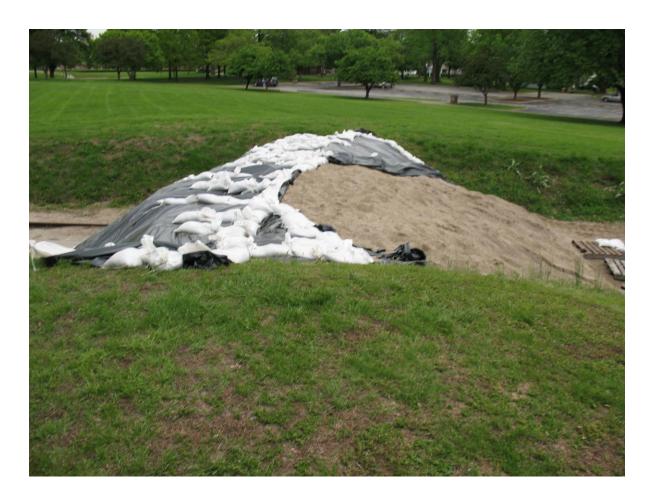
Figure H-5-12. Soil Pile with Plastic Sheeting Closure

The final type of non-culvert closure considered within this document is soil pile with plastic sheeting and/or soil baskets. Both of these involve moving soil into place to provide a water barrier. Soil piles covered with plastic can provide sufficient weight and a good enough water barrier for providing temporary closure (Figure H-5-12). An alternative option is utilization of an engineered container system, referred to as soil baskets, one type of which is shown in Figure H-5-13. Soil pile/baskets can be a cost-effective way to set a temporary closure, but caution is warranted. First, heavy equipment should not be placed on a levee when it is saturated. This could cause the levee to fail or be seriously damaged under the additional weight. Soil piles or baskets usually involve the use of heavy construction equipment to move the soil in place in an efficient manner. The required equipment and potential for damaging the levee should be considered when assessing the risk of placing these type closures. Another issue of concern is when soils used to set the closure are taken from the landside slope of an adjacent levee section. This is not recommended and can weaken the levee section where the soil is taken by shortening the seepage path or causing an unstable slope.

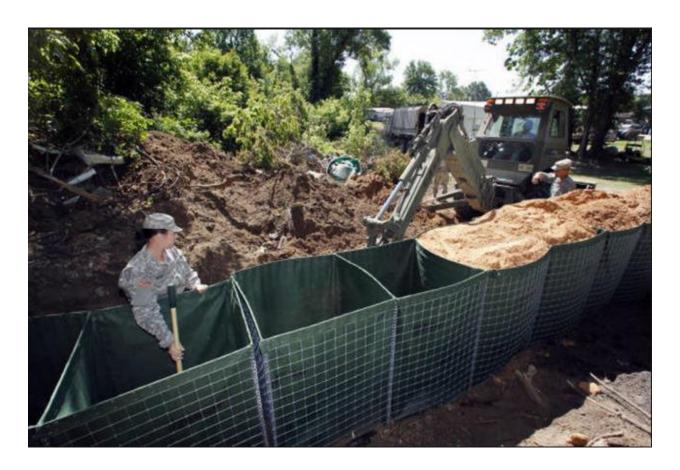
Figure H-5-13. Soil Basket Flood Barrier under Construction

There are multiple types of soil basket systems and each has their own advantages/disadvantages. Some require specialized equipment specifically for constructing the flood barrier system. It is doubtful these would be part of a designed closure system for levees due to the equipment requirements. Most of these systems use typical construction equipment (front end loaders, etc.) and require a certain number of personnel to set the closure in a timely manner. Special care must be taken to ensure the foundation of the soil pile/basket closure is able to withstand the hydraulic loading. There has been at least one known case history when a soil basket system failed and flooded the interior because of seepage and piping of material below the base of the soil baskets. More information on this is provided in the case histories section of this chapter.

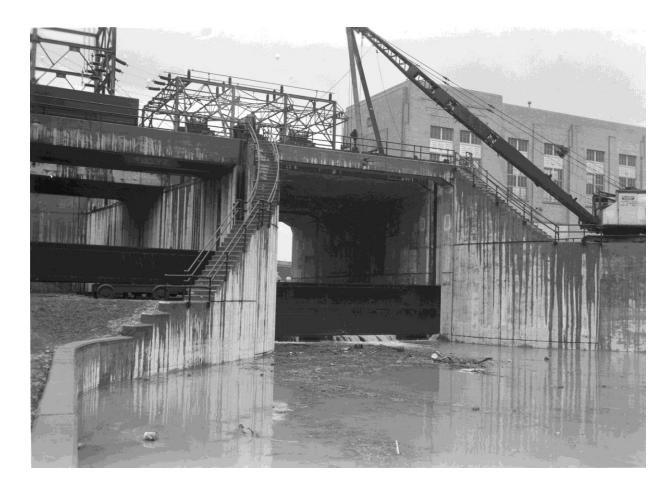
Figure H-5-14. Mill Creek Pump Station Closure Bay

typically large steel gates/bulkheads that are designed as an integral part of a gravity monolith section. They are usually associated with flood protection systems in highly urbanized areas where high capacity pump stations are utilized for the removal of interior drainage. When the river is low, the opening allows gravity flow to remove interior water through the closure bay. When the river is elevated, the large gates/bulkheads are lowered into place and interior drainage is removed via pumping operations. Figure H-5-14 shows the original completed construction of the Mill Creek Pump Station closure bay in Cincinnati, OH. Note the section where the large steel bulkheads are lowered into place through the use of a crane and the adjacent area where the bulkhead are stored.

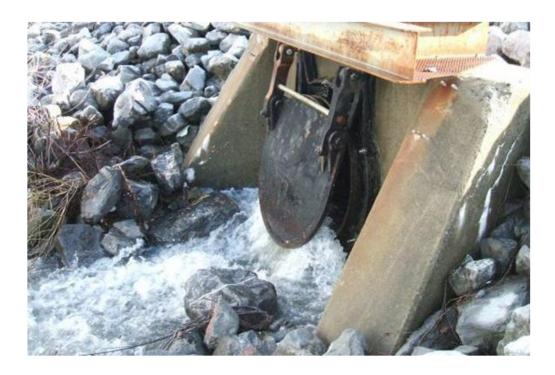
Figure H-5-15. Culvert Flap Gate Closure

One of the more common types of closures for culverts is flap gates. They are very popular because of their relatively low cost, automatic functionality, and wide range of sizes. Flap gate closures are placed at the outlet end of the culvert and are designed to remain shut at all times; thus, when the river rises above the outlet end of the pipe, it will seal against the end of the pipe and keep water from entering the culvert. When the river is low, their simple design allows interior drainage to discharge through the outlet end by applying a small amount of water pressure from flowing water to "crack" the bottom of the flap gate open, as shown in Figure H-5-15. Once the flow subsides, the valve is designed to close back against the vertical face of the culvert. Sometimes the flap gate may be 'propped' open to ensure an obstruction doesn't block the flap gate in the closed position, such as shown in Figure H-5-16. When this type of system is

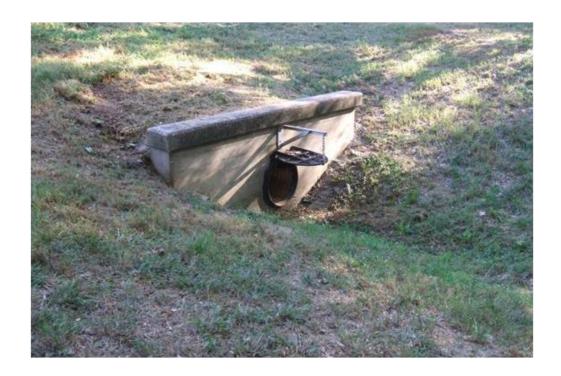
Figure H-5-16. Culvert Flap Gate Modified to Remain Open

used, it is important to realize the flap gate must be manually shut ahead of rising floodwaters otherwise unrestricted flow through the culvert will occur and flood the interior.

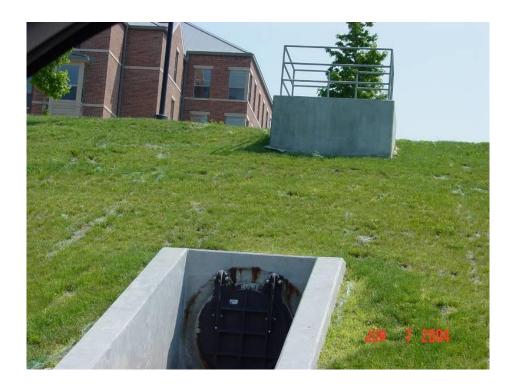
Figure H-5-17. Culvert with Flap Gate and Sluice Gate Closure

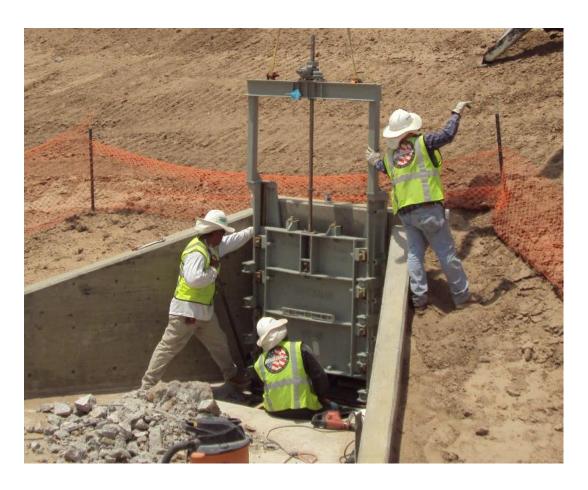
Figure H-5-18. Sluice Gate Being Constructed at Outlet End of Culvert

Sluice gates may be placed at the outlet end of the culvert to keep it from getting significant interior pressure from riverside water levels. When the sluice gate is located along the pipe within a gate well, the pipe itself should be designed for interior pressure applications from elevated river levels.

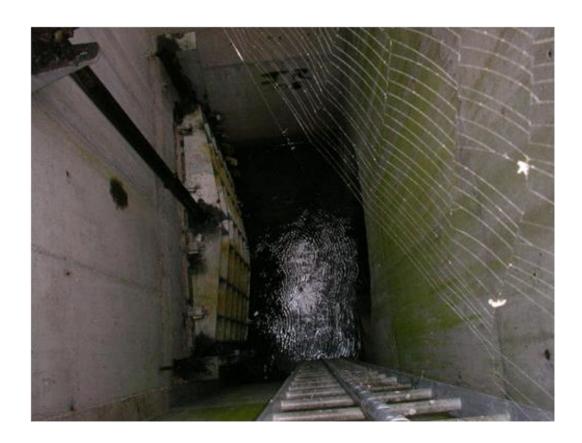
Figure H-5-19. View of Sluice Gate Looking Down from Top of Gate Well

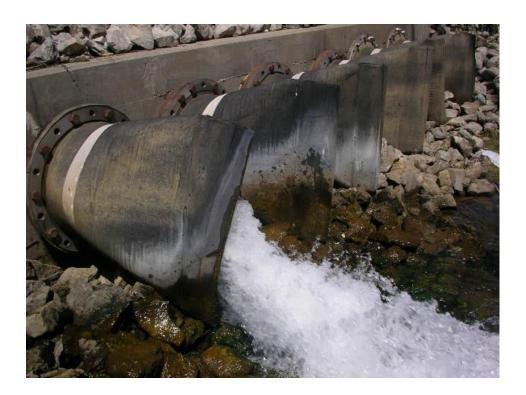
Figure H-5-20. Duck Bill at Outlet End of Culvert

Duckbill valves are one piece elastomeric devices that act as a check valve (only allow one way flow). They are attached to the outlet end of the culvert to prevent backflow through the pipe. They are referred to as duckbill valves because they resemble the bill of a duck (see Figure H-5-20). Duckbill valves are designed so they are closed when no flow through the pipe is present. Once the culvert starts to receive interior flow, the vertical seal will open under pressure allowing water to drain out of the duckbill and culvert. It usually takes 1-2" of water above the

invert of the culvert in order to crack open the seal of the valve. It is designed to re-seal once the interior water is drained sufficiently. When the river level rises on the exterior of the culvert, the vertical seal is designed to keep exterior water from entering the pipe. Duckbill closure devices have been used successfully in many installations and are a popular option when the theft of flap gates is a recurring problem and in areas where corrosion of steel products could be a significant issue. Generally speaking, they require no maintenance and are quite cost effective compared to other closure features.

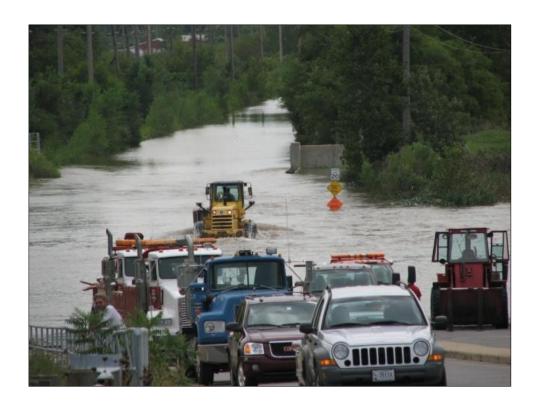
Figure H-5-21. Flooding of Gary, Indiana at Chase Street Post/Panel Closure

The Gary North Local Flood Protection Project (LFPP) is a federally-constructed, locally operated/maintained levee segment located along the Little Calumet River in northern Indiana. The segment is approximately 8.4 miles long (8.0 miles of levee embankment, 0.4 mile of floodwall). It is located in a heavily industrialized area. There are a total of seven different nonculvert closure systems within this segment (six sandbag and one post/panel closure). The single post/panel closure was designed to close off flow from entering through Chase Street. According to the post flood report, the local sponsor lacked experience in both the planning and setting of the post/panel closure. It was noted they weren't sure when to start setting the closure and how it was to be put together in a timely manner. During the 2008 flood as the Little Calumet River was rising, the local sponsor was unable to set the post/panel closure and in a last ditch attempt tried to provide closure by placing a sand pile with plastic across the closure. This was unsuccessful as water poured into the interior through the Chase Street closure opening as the river rose above the sill elevation. This resulted in flooding of the interior, as shown in Figure H-5-21 where the closure is visible in the background. Consequences were limited primarily to economics as the interior flooding through the closure resulted in road damage and portions of the interstate being closed for a period of time (see Figure H-5-22).

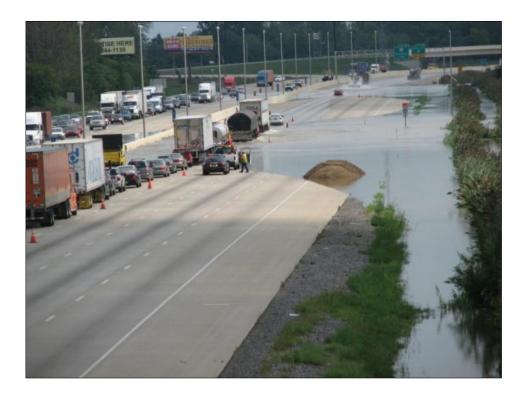
Figure H-5-22. Flooding of Interstate in Gary, IN due to Failure of Post/Panel Closure

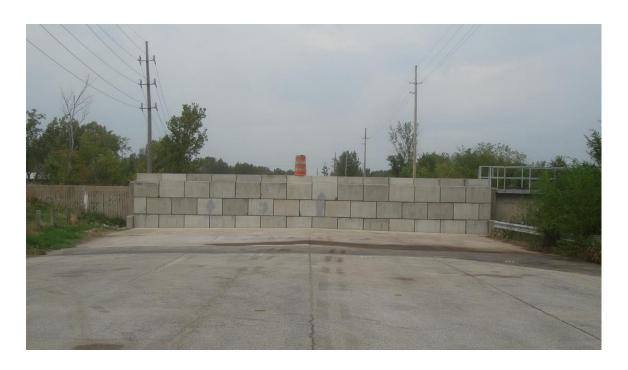
Figure H-5-23. Semi-Permanent Concrete Block Wall at Chase Street (Gary, IN)

Following the flood, the local sponsor requested to permanently seal off the closure to avoid a repeat of what happened in 2008. The local sponsor felt there were multiple other access points to reach the area such that providing permanent closure at Chase Street would have little overall effect on traffic patterns. The local sponsor, working with an independent engineering firm, opted for large, removable concrete blocks to seal the closure, as shown in Figure H-5-23. These could be moved in an emergency, but it is unlikely they will ever be moved unless access to the area needs to be provided in the future.

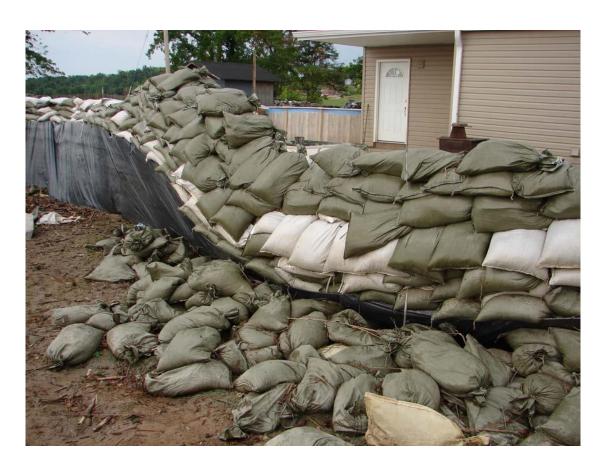
Figure H-5-24. Failure of Soil Basket System (Winfield, MO)

on-coming floodwaters, a combination earthen berm and soil basket levee was quickly constructed around the town with the use of National Guard troops. As the floodwaters reached the soil baskets and started to buildup, seepage started to emanate from under the soil baskets at the location of an 18" iron pipe that hadn't been noticed previously. A secondary line of soils baskets was immediately placed landward in the area around the leaking pipe; however, the soil supporting the baskets quickly saturated and failed under the weight of the soil baskets that were topped with sandbags (see Figure H-5-24). While this wasn't a closure system failure, it was a failure of a soil basket system that is commonly used for levee closures. The cause of the failure was the leaking pipe below the soil baskets that wasn't noticed and saturated the soil supporting the baskets.
